JOSÉ R. DOMINGO Y JUAN FERNANDO RÓDENAS
B. ESPACIOS EXTERIORES / OUTDOOR SPACES

REHABILITACIÓN DE DOS PLAZAS HEXAGONALES EN EL POBLADO HIFRENSA (ANTONIO BONET, 1967-75) / REHABILITATION OF TWO PLACES IN THE HIFRENSA SETTLEMENT

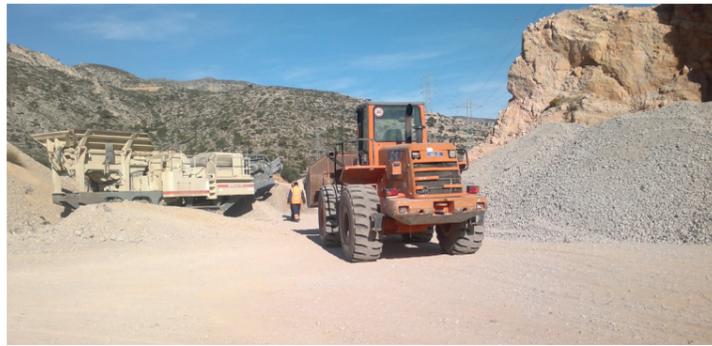
figura 1. Reciclaje de las placas de hormigón / recycling concrete slabs.

The aim of the intervention has lain in removing completely the interventions made in the 80s and returning the square to its original state. It has been necessary to repair or replace the elements affected by the pathologies of the garages which are located on the lower level. The test bores have revealed the composition of the original concrete which is characterized by the use of a specific aggregate called 'cigronet'. The 'cigronet' is composed largely by light and dark gravel and to a lesser extent by reddish and ocher gravel from 'Mallafre' Quarry which is located in the neighboring municipality of Montroig del Camp. Several tests with different granulometric composition have been tested and the time required to wash the concrete surface before it sets to recreate the original appearance of the pavement has been estimated thanks to them. The demolished concrete plates (on the two places) were moved to a nearby site where they were crushed (Figure 1) to be recycled as the base of the new intervention thereby improving the drainage and settlement because the initial draft did not have any base.

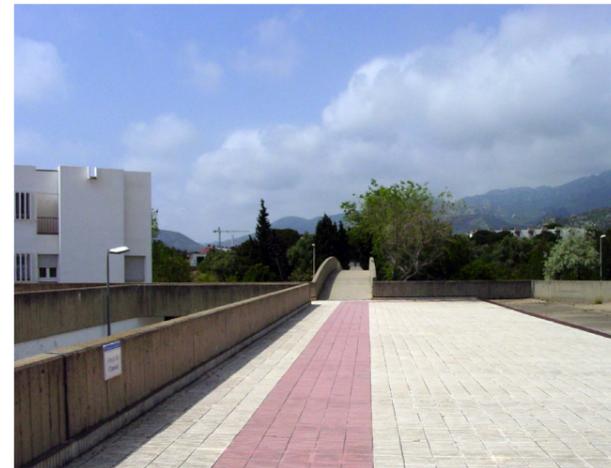
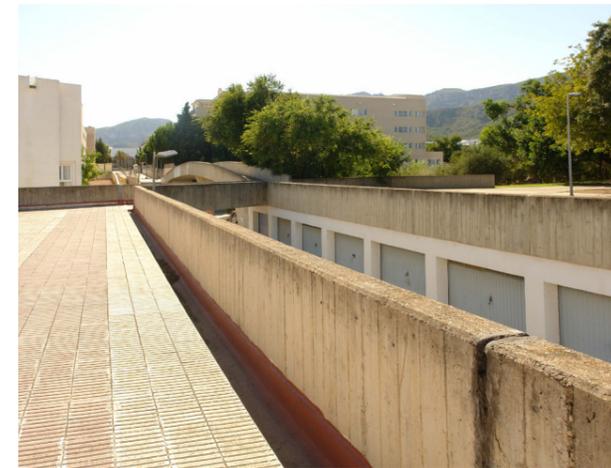
figuras 2 y 3. Plaza hexagonal. Estado inicial/ Hexagonal Square. Initial state

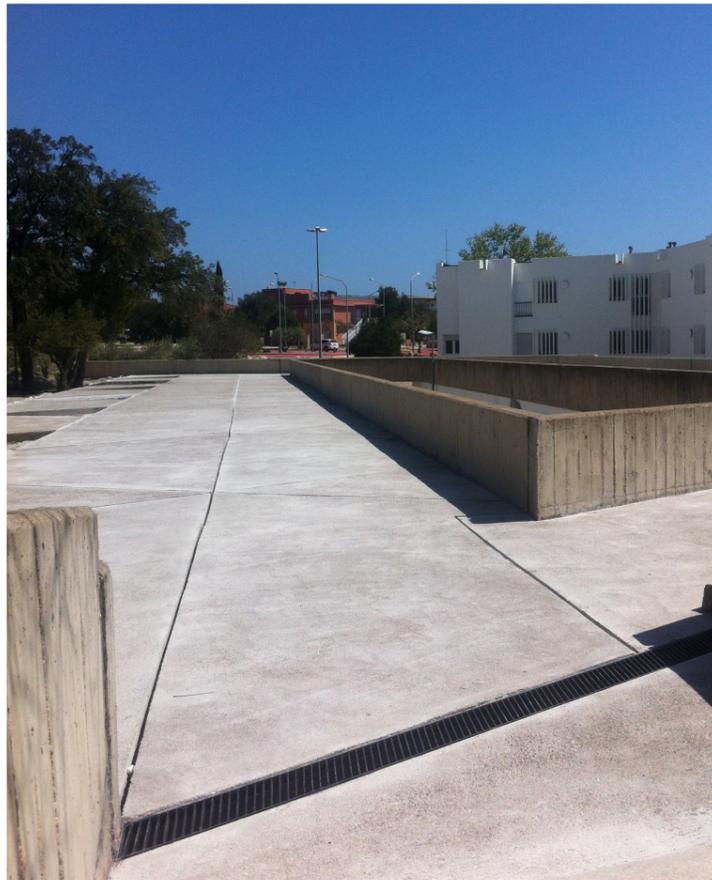
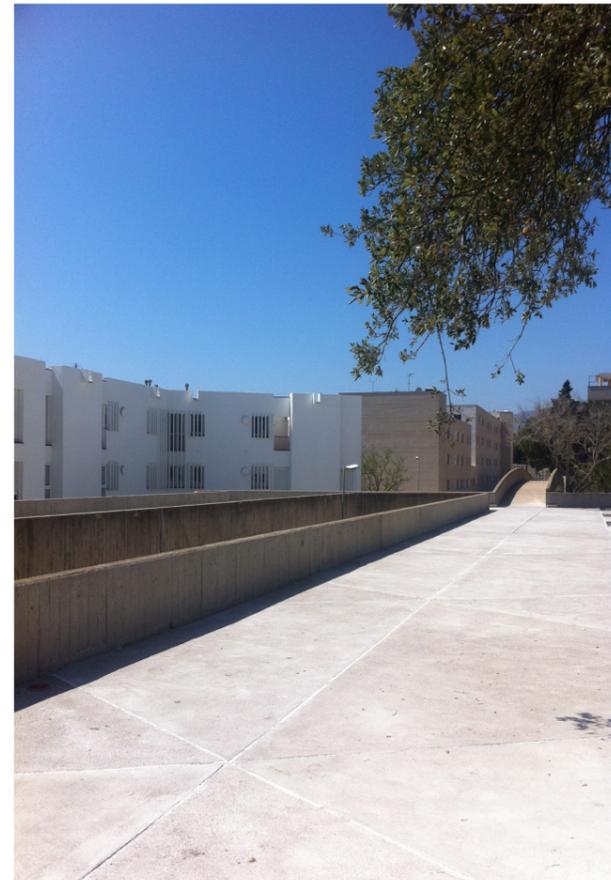
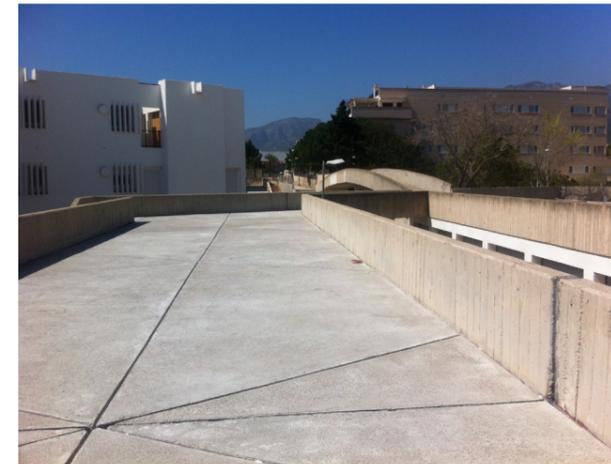
figuras 4, 5, 6. Plaza hexagonal. Estado final Hexagonal Square. Final state
